## SECTION D TROUBLESHOOTING ACCORDING TO FMT STATUS LINES

This section is intended to be used when a problem occurs during operation and a reject code is sent from the formatter (FMT) to the host/controller. The user can then refer to the reject code table, that reference the associated troubleshooting flow chart. Because the error could result from an operator mistake or a problem in the MTU, the user should evaluate the quickest method to correct the problem. All PCAs described in this section are located in the FMT unless otherwise noted.

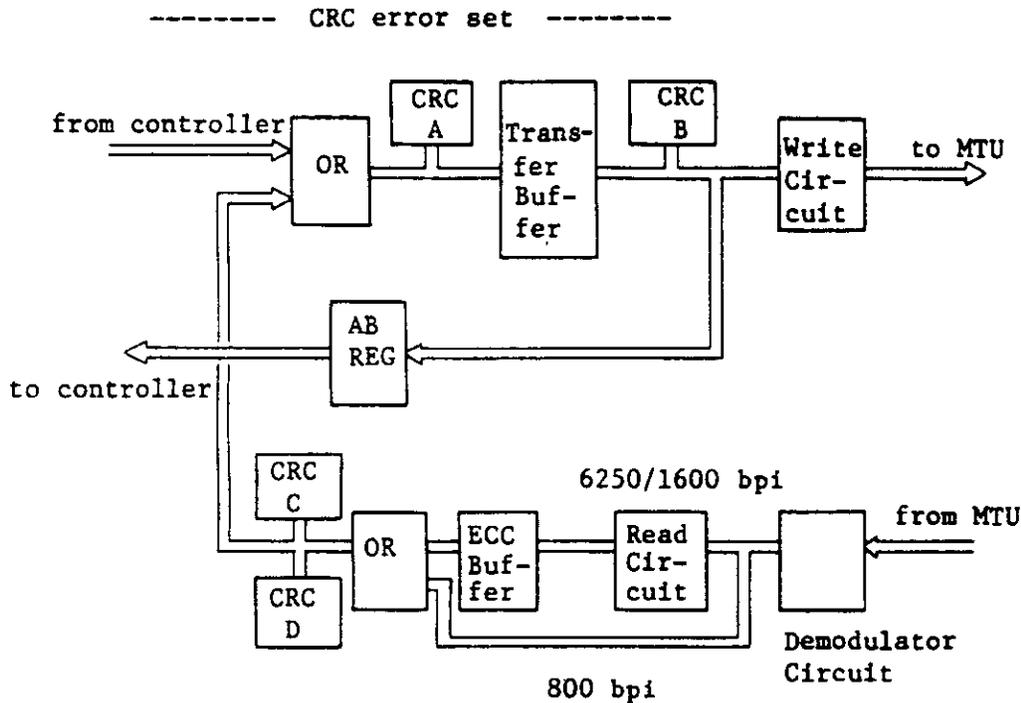
Figure D.15 CRC generation circuit

Mode	6250 bpi	1600/800 bpi	Sense
	A ≠ B	A ≠ B	P compare
	B ≠ D	B ≠ C	CRC III error
Read	A ≠ B	A ≠ B	P compare
	B ≠ D	-	CRC III error
Read backward	A ≠ B	A ≠ B	P compare
	C ≠ Match pattern	-	CRC III Error

- o CRCA : CRC pattern is generated from transfer buffer input.
- o CRCB : CRC pattern is generated from transfer buffer input.
- o CRCC : CRC pattern is generated from read data.
- o CRCD : Set CRC of read data at 6250 bpi.
- o When CRC III error or P Compare error is indicated (in the DSB11 FRU1 and FRU2 described below).

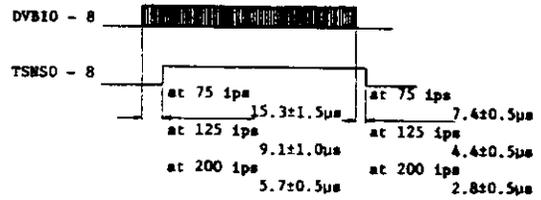
Figure D.16 6250 bpi data check

- Check the wave-form during write by Field Tester. (K0130)
- 1) Set 9042 fci (GCR mode) after being 3200 fci (PE model) ...  $V \geq 1.0V$  for a few seconds.
  - 2) Set 9042 fci after set .....  $V = 2.0V \pm 15\%$  SAGC.
  - 3) Perform the tape running backward which is written .....  $V \geq 1.0V$  in 9042 fci.

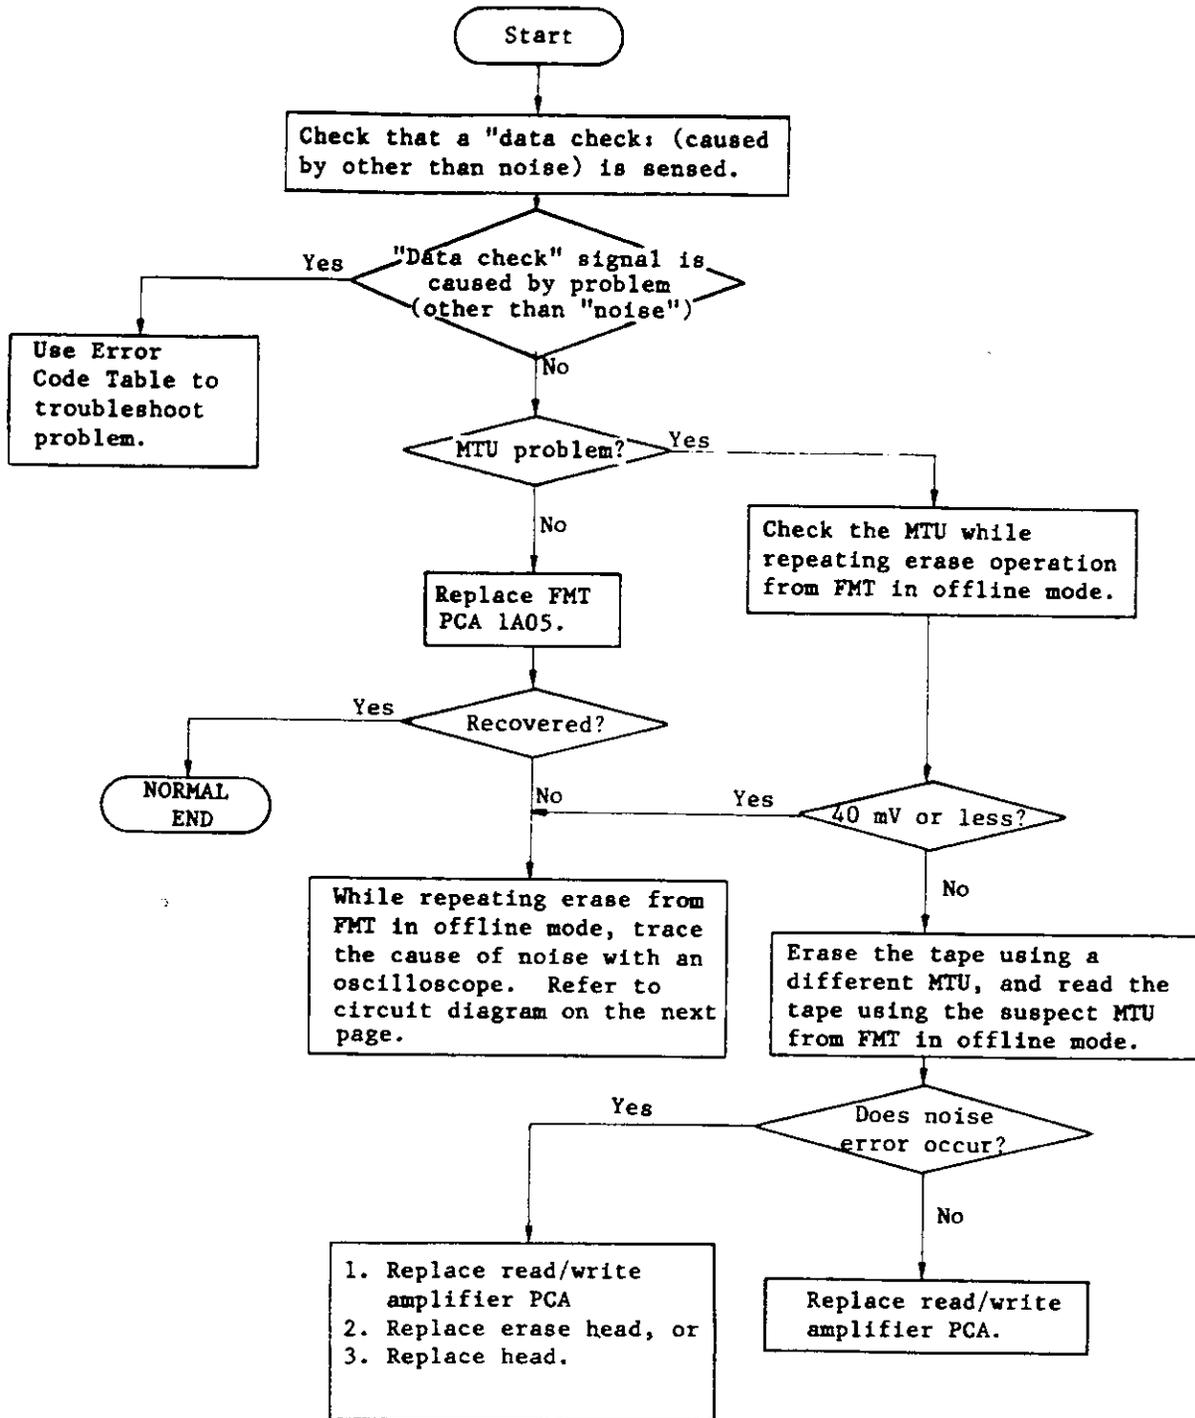
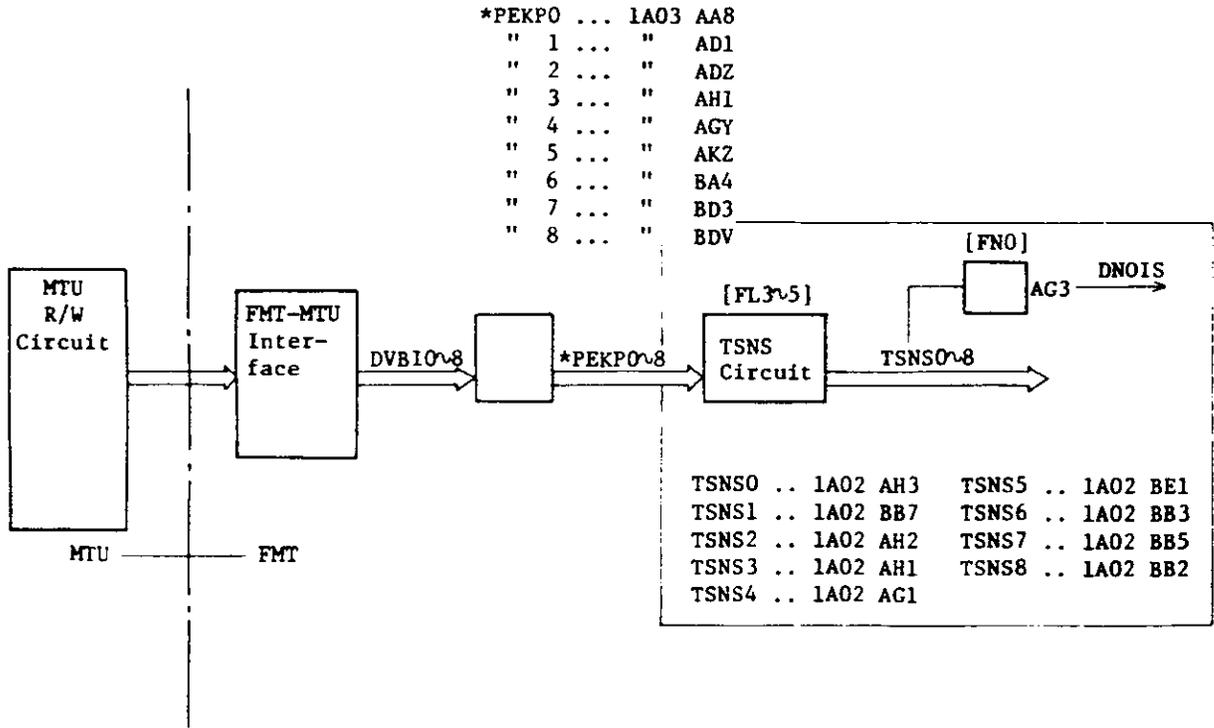
Figure D.27 Noise troubleshooting

Noise error occurs when:

- (1) Data check is set to on during the read or read backward command.
- (2) A noise block is detected read or read backward command.
- (3) Data is detected during the erase, write tape mark, or write command.

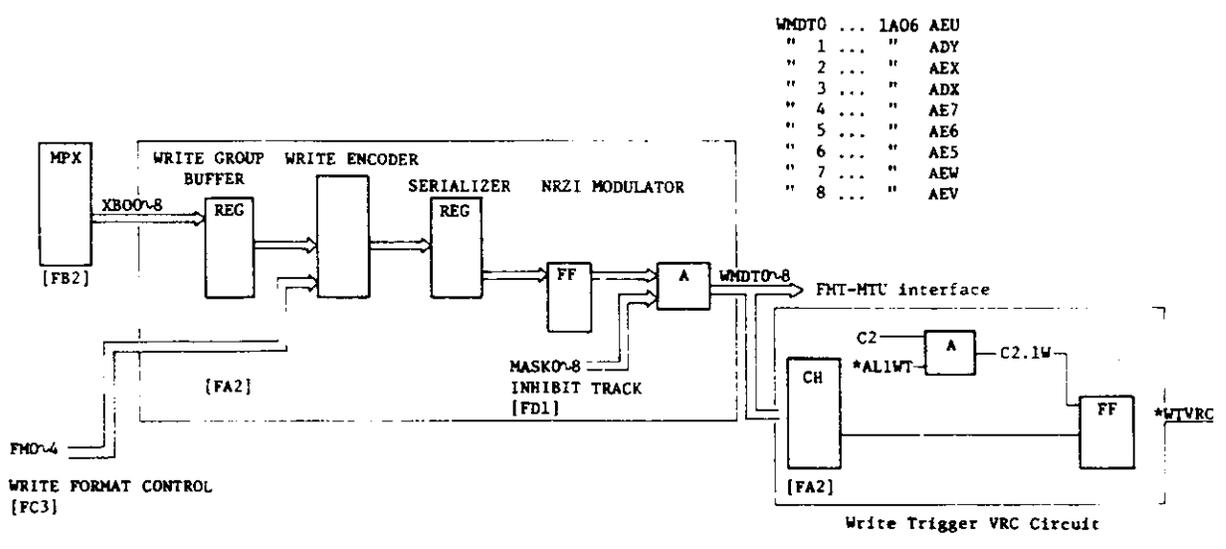
Figure D.28 Write trigger VRC circuit

D2120	W-VRC Error
-------	-------------

W-VRC error occurs when:

- (1) Parity error occurs in WTDO through 8 at write trigger VRC circuit. In this case, "IBG detected" is not set.
- (2) Writing on creased tape. In this case, "IBG detected" is set.

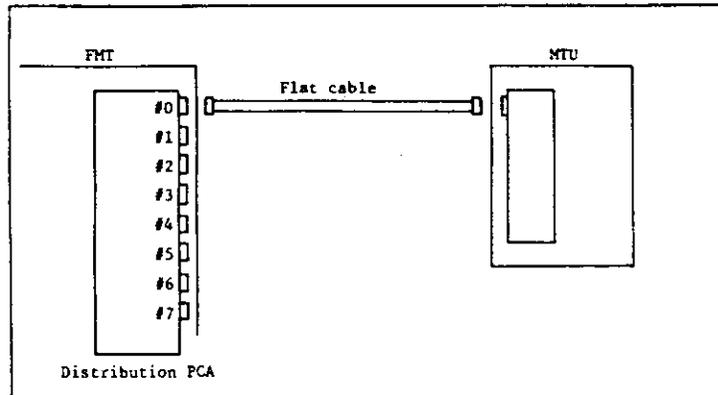
Figure D.30 FMT-MTU cable check

If a failure occurs in a specific MTU, check the cable between the FMT and the MTU.

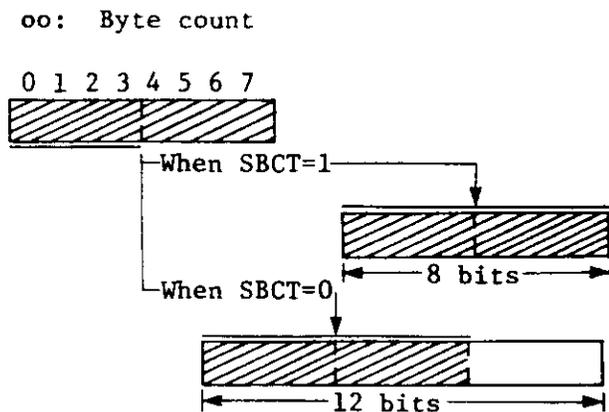
(9) To set the byte count, the field tester is operated in the following procedure. When register address \$3F is displayed in the register and is already set at a predetermined byte count value, this procedure may be omitted.

S0 - S7 \$B2  
 CNT-SW ON  
 S0 - S7 \$00  
 SSS-SW ON  
 S0 - S7 \$3F  
 SSS-SW ON

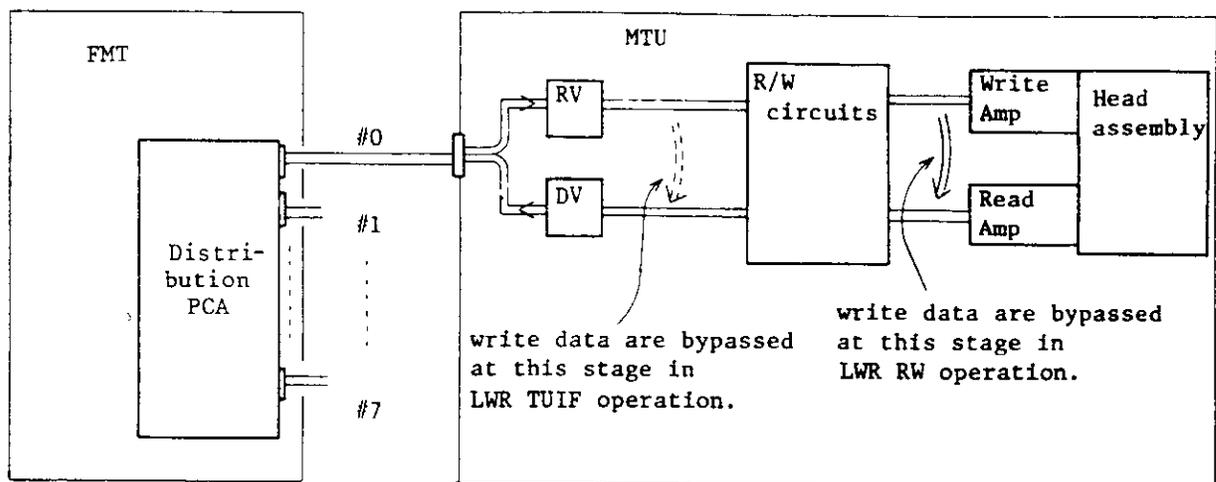
Figure D.31 LWR and LWR2

-- Restriction --

- 1) Reject Code 207 is set when the MTU detects BOT or is in the 800 bpi mode.
- 2) Executing LWR RW operation clears the SAGC-count of the MTU.

If LWR RW operation has resulted in failure, LWR TUIF operation should be executed. Then the faulty PCA can be replaced.

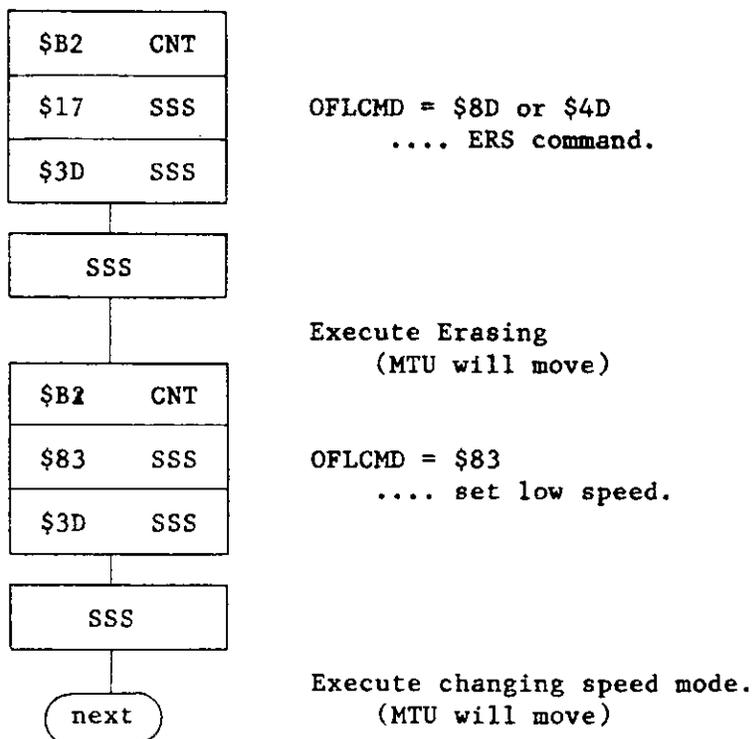
- (4) To allow the MTU to move forward if the MTU is in the BOT detected status, issue WRT, WTM, or ERS command to the MTU.
- (5) If a specific tape speed is to be tested set either the high-speed or low-speed command.
- (6) If the MTU is in the BOT detected status, set density-select bit ('0' or '1').

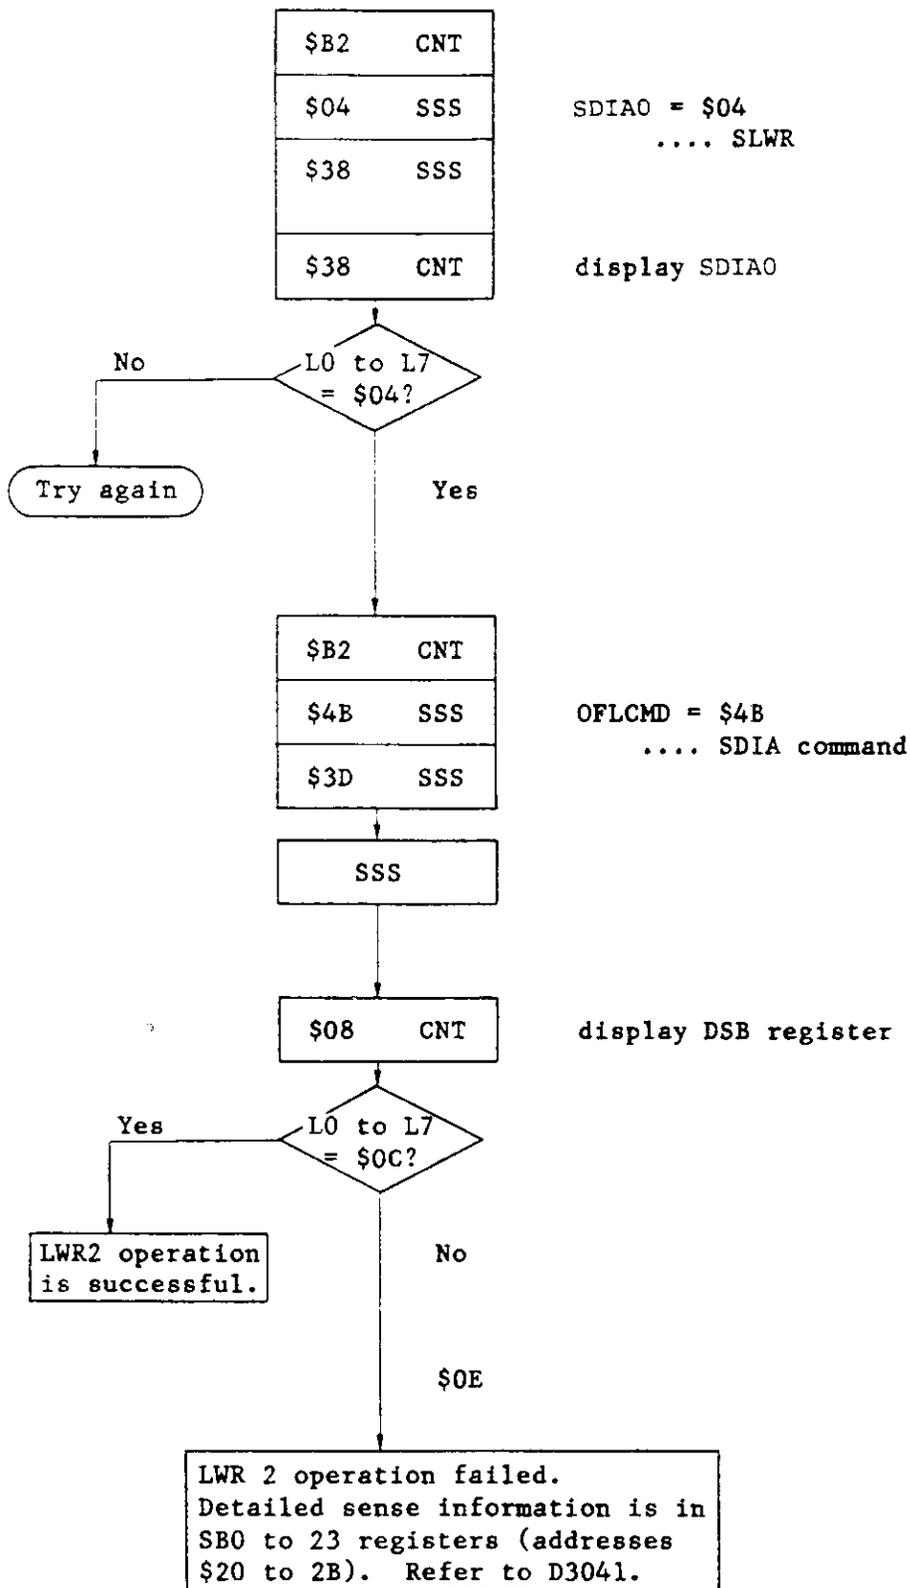
(7) Store SLWR bit (\$04) to SDIA0 register. Issue SDIA0 command.
